ABBREVIATED PRELIMINARY ASSESMENT

OCHOCO MINE

Ochoco National Forest
Crook County, OR

November 2004

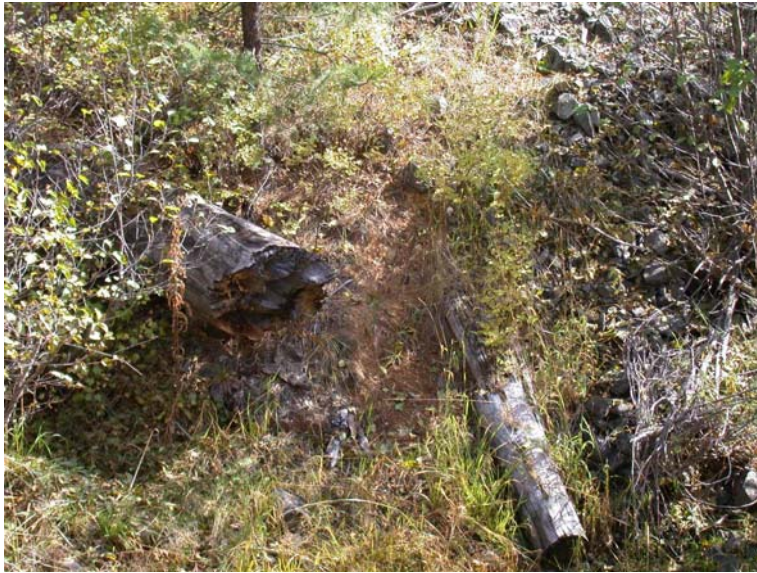
Photo 1. Waste Rock Material under Andesite Rocky Material
Niton Sample ID# 44. Arsenic 103 mg/kg; Nickel 23,590 mg/kg
(Photo by Boles)

Based on the In Situ screening of the waste rock and tailings with the Niton XRF unit, physical hazards associated with the Site, and EPA's APA Checklist (Appendix B), it is recommended that a Site Inspection (SI) be completed. A more thorough search of the area is required over that done during the site reconnaissance performed for the APA. As part of this inspection, a thorough study of the area to determine the extent of disturbance and contamination is warranted. The area should be sampled to determine the presence of all waste material and tailings, and if present, the potential waste rock and tailings should be sampled at depth and a determination of volumes should be calculated. Acid base accounting (ABA) is required if waste material is present besides what had been observed during this assessment.

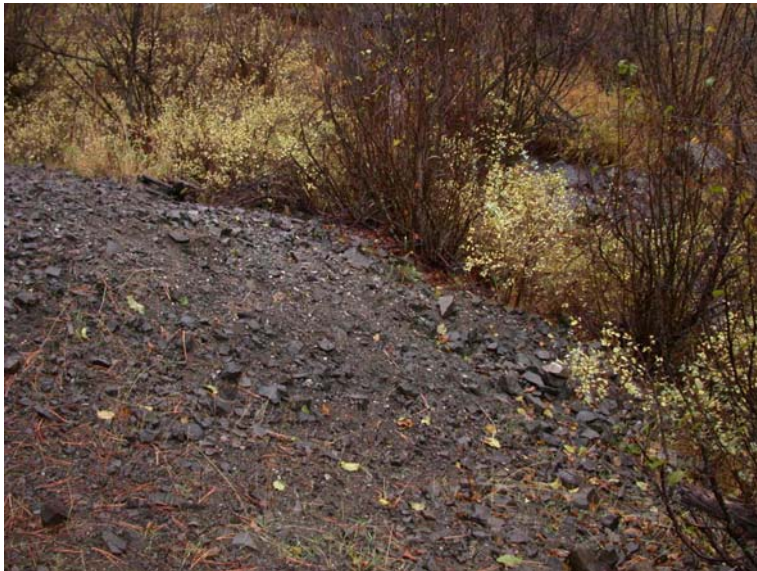
Photo 2. Waste Rock Material along Ochoco Creek. .(photo by Boles)

It is recommended that a Site Inspection (SI) be performed because of the concentrations of various elements as noted and the fact the waste rock material is adjacent to Ochoco Creek.

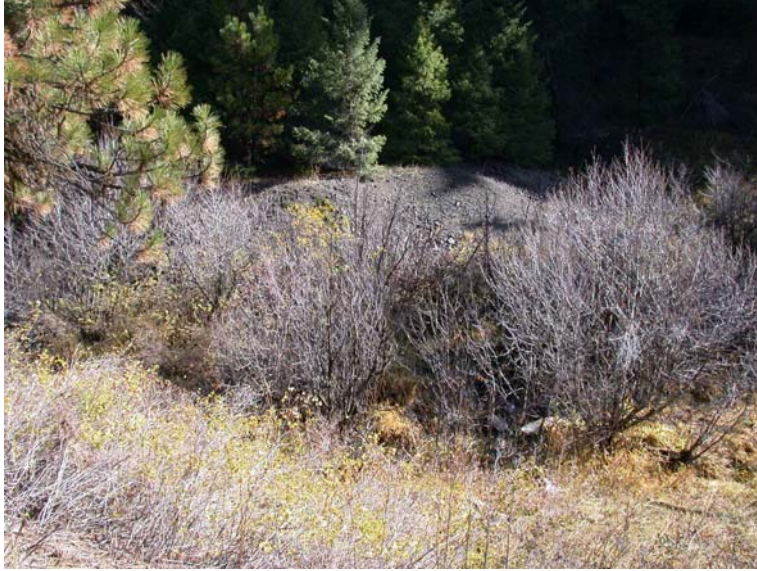
Photo 3. Waste Rock Pile. Ochoco Creek is within willows in foreground. (photo by Boles)

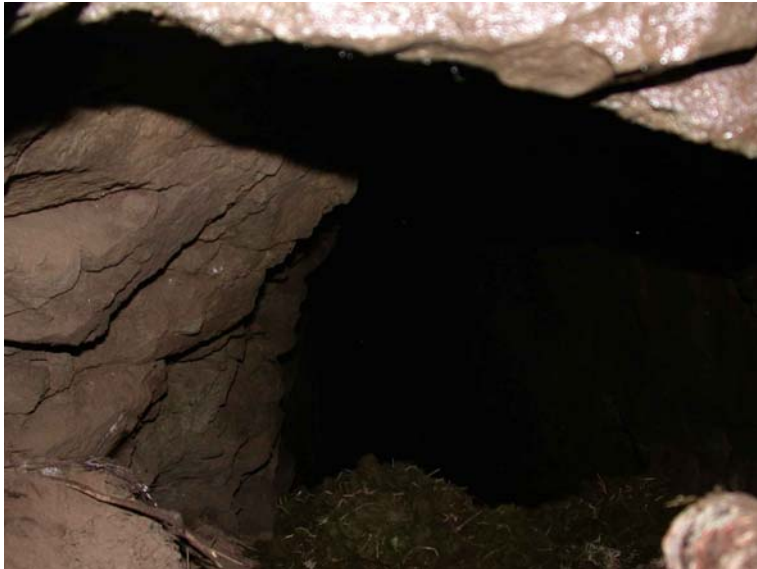
Photo 4. Shot Inside of Adit, Taken at Portal Entrance. (photo by Boles)

The Site poses a physical hazard to the general public recreating at the Site in that the adit is accessible.

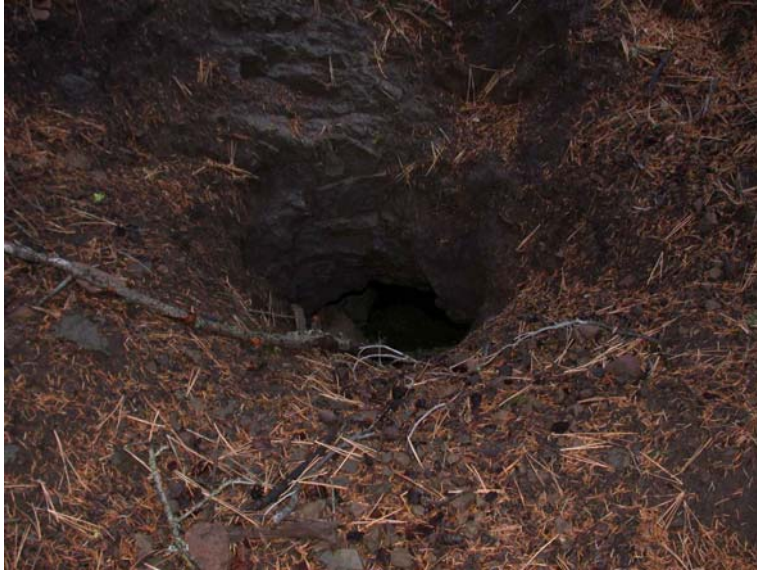
Photo 5. Partially Collapsed Portal. (photo by Boles)
